### **Public Buildings Enhanced Energy Efficiency Program**

#### **Final Report Investigation Results For Vermilion Community College**

## Vermilion Community College Energy Investigation Overview

### **SCREENING RESULTS FOR VERMILION COMMUNITY COLLEGE**

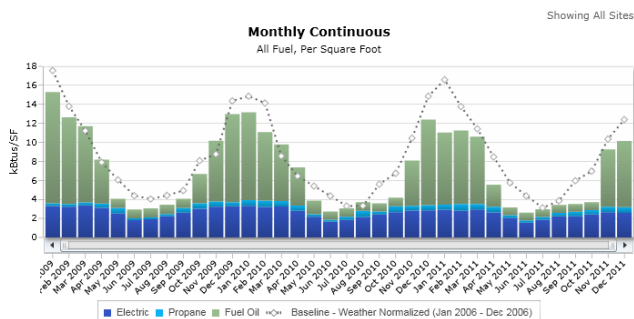
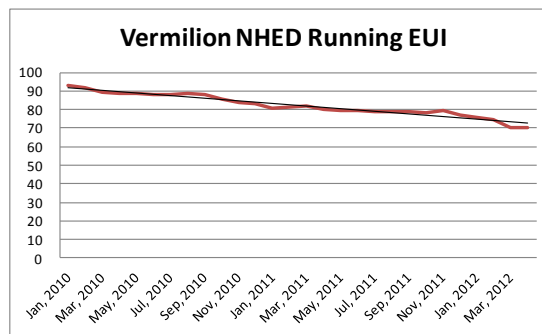
Vermilion Community College Consumption Report  
Total energy use decreased 10% during the period of the investigation
